Inspection Report

IAN DOUGLAS INSPECTIONS

873 S Main St.

Paradise, CA

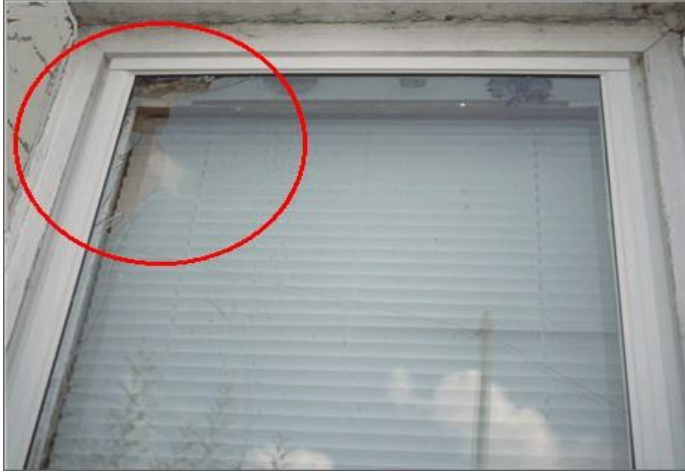
7) Window Conditions

R

There was a broken window at the North side of the home.
Contact a general contractor for repair.

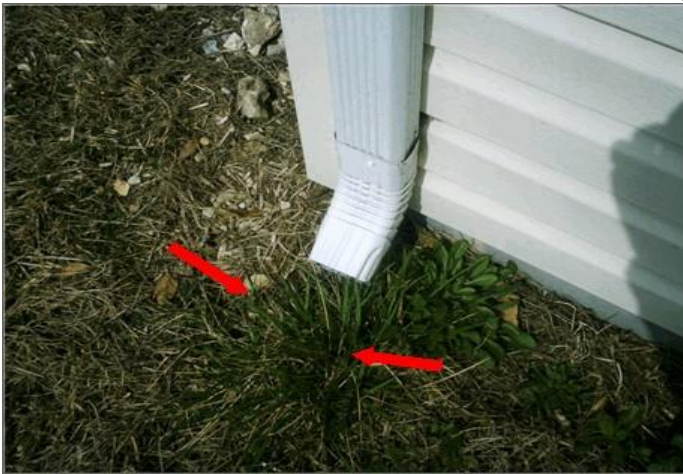
13) Gutter & Downspout Issue

14) 1: The downspout on the South side of the home was

missing a splash plate. The splash plate helps direct rainwater away from the foundation of the home. These can be purchased at your local hardware store and are relatively inexpensive to relapse. If you're not familiar with them contact a general contractor for repair.

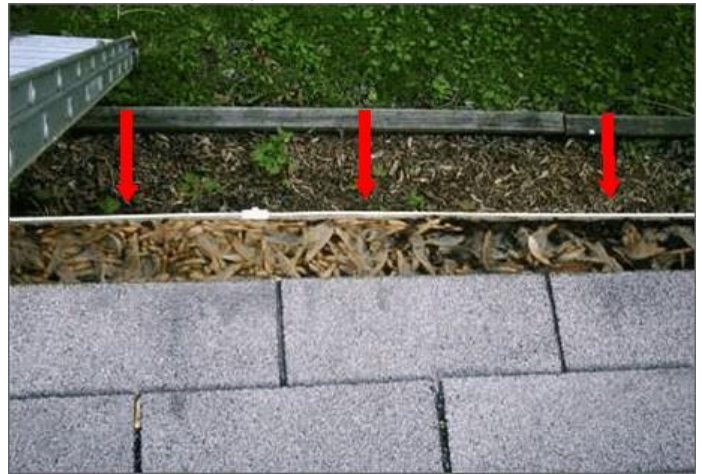
Issue 2: The gutters were full of debris. It is recommended that the gutters be cleared of debris so that rainwater can flow properly. Contact a general contractor for repair.

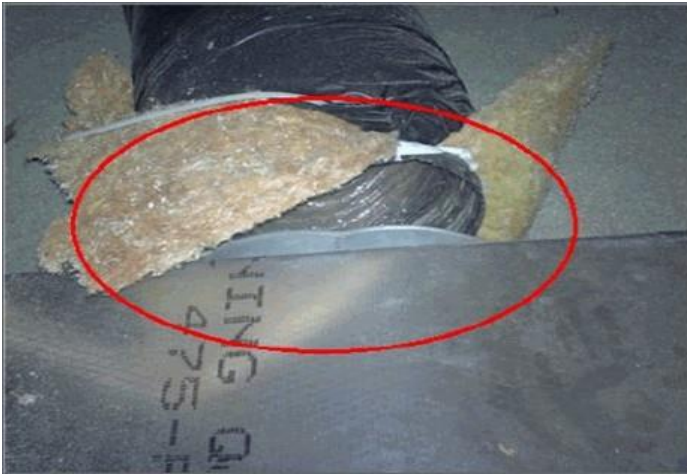
19) Distribution Conditions

S

Safety Issue: The cool air return vent in the attic was disconnected from the furnace. This means that the furnace is sucking unfiltered air from the attic space and distributing it throughout the home. The insulation and dust may pose a health hazard. This condition will also significantly reduce the efficiency of the furnace. It is recommended that a certified HVAC contractor be contacted as soon as possible for repair.

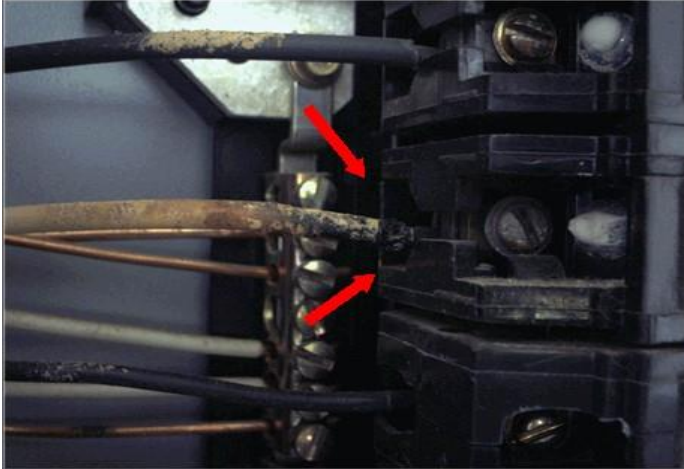
26) Electrical Panel Conditions

S

Safety Issue: There were some charred wires in the main electrical panel which is an indication of overheating. this is considered a fire safety hazard and should be repaired as soon as possible. Contact a certified electrician for repair.

Electrical	26	Safety Issue: There were some charred wires in the main electrical panel which is an indication of overheating. this is considered a fire safety hazard and should be repaired as soon as possible. Contact a certified electrician for repair.
Plumbing	31	Safety Issue: The TPR Valve was missing a discharge pipe that extends to within 6" of the floor. this may pose a safety hazard if the water heater were to discharge hot water. Contact a certified plumber for repair as soon as possible.
Kitchen	56	The garbage disposal appeared to be leaking. Contact a certified plumber for repair.
Basement	75	Safety Issue: The basement stairs were missing handrails. this is considered a safety hazard. Contact a general contractor for repair.

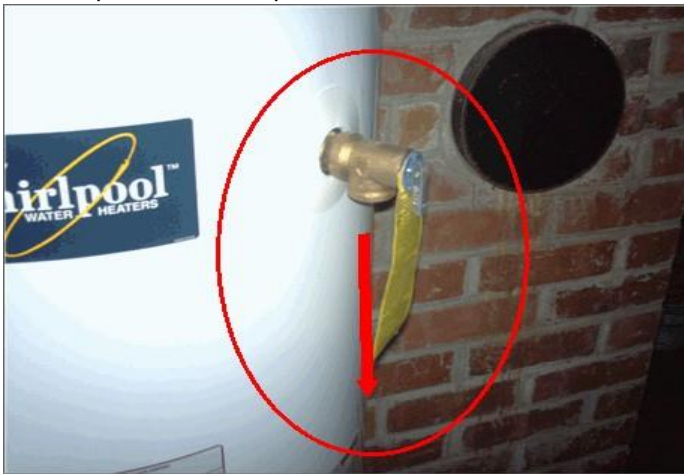
31) Water Heater Conditions

S

Safety Issue: The TPR Valve was missing a discharge pipe that extends to within 6" of the floor. this may pose a safety hazard if the water heater were to discharge hot water. Contact a certified plumber for repair as soon as possible.

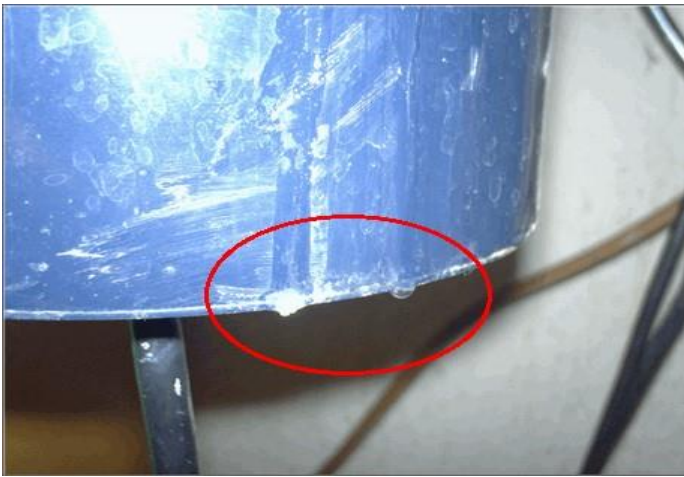
56) Garbage Disposal Condition

R

The garbage disposal appeared to be leaking. Contact a certified plumber for repair.

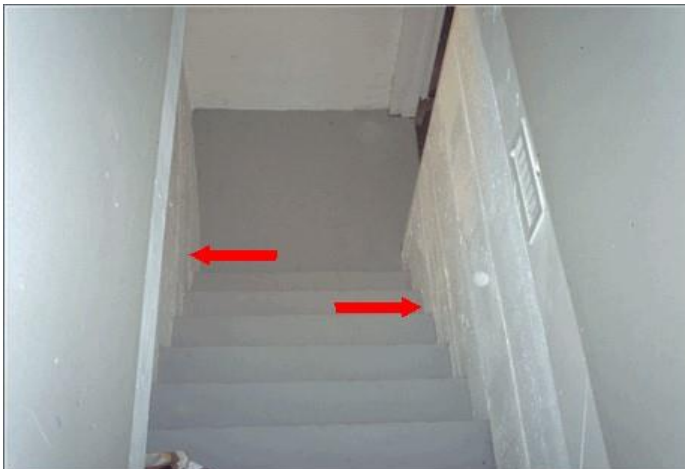
75) Basement Stair Conditions

S

Safety Issue: The basement stairs were missing handrails. this is considered a safety hazard.
Contact a general contractor for repair

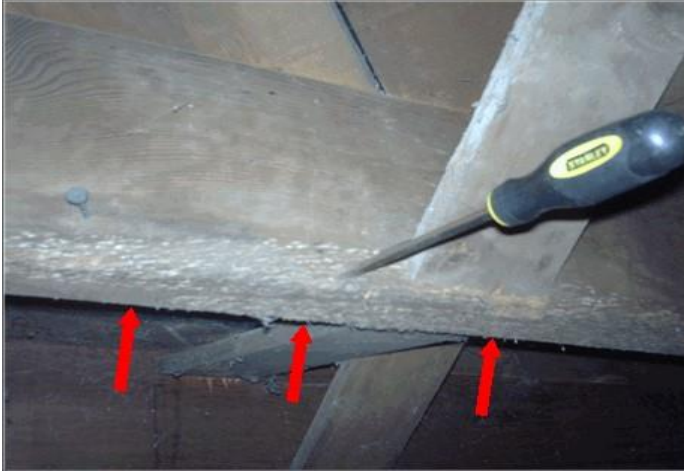
97) Flooring Support Conditions

R

Issue 1: There appeared to be termite damage on several of the floor joists in the basement. Contact a certified contractor for repair.

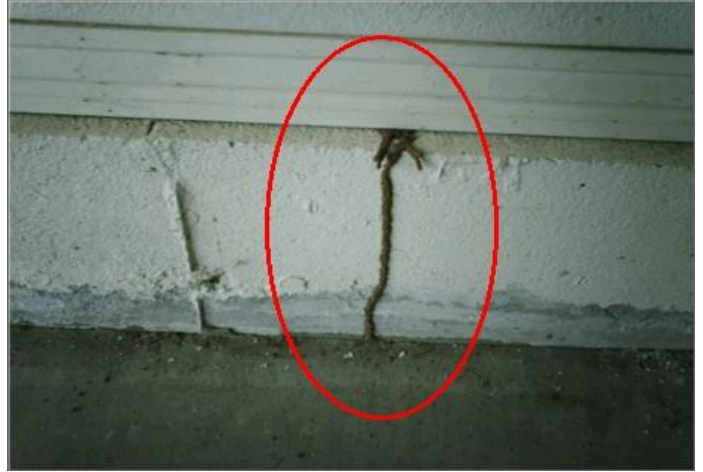
98) Issue 2: There was evidence of active termites in the basement area. It is recommended that a termite inspection be performed.

Contact a certified pest inspector for further evaluation and an estimate of damage.
